# Ford Electronic Throttle Control

By Glen Benard *technical contributor*

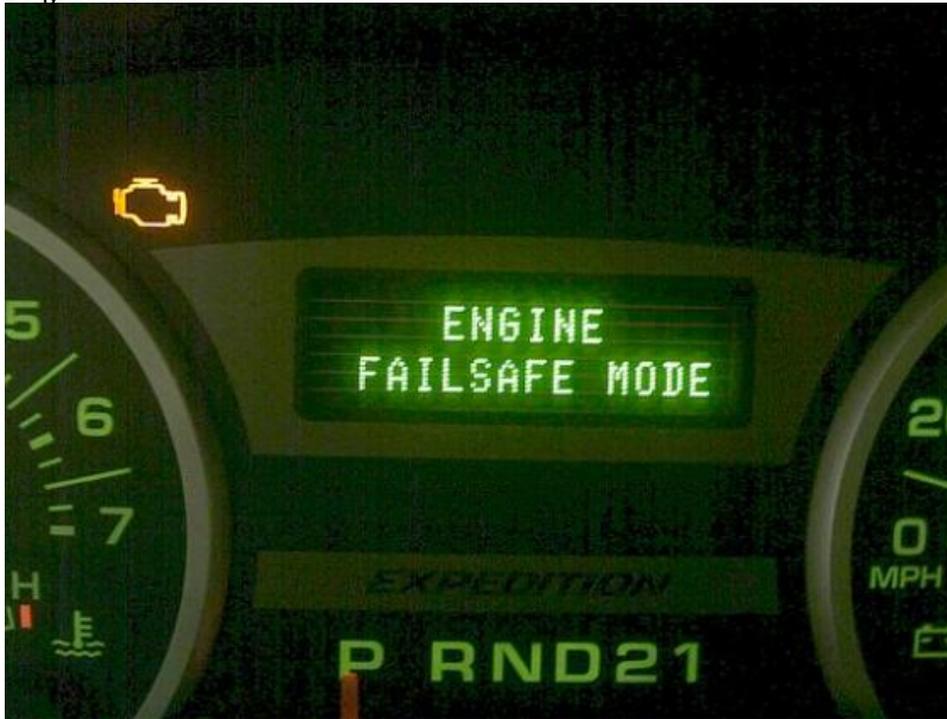
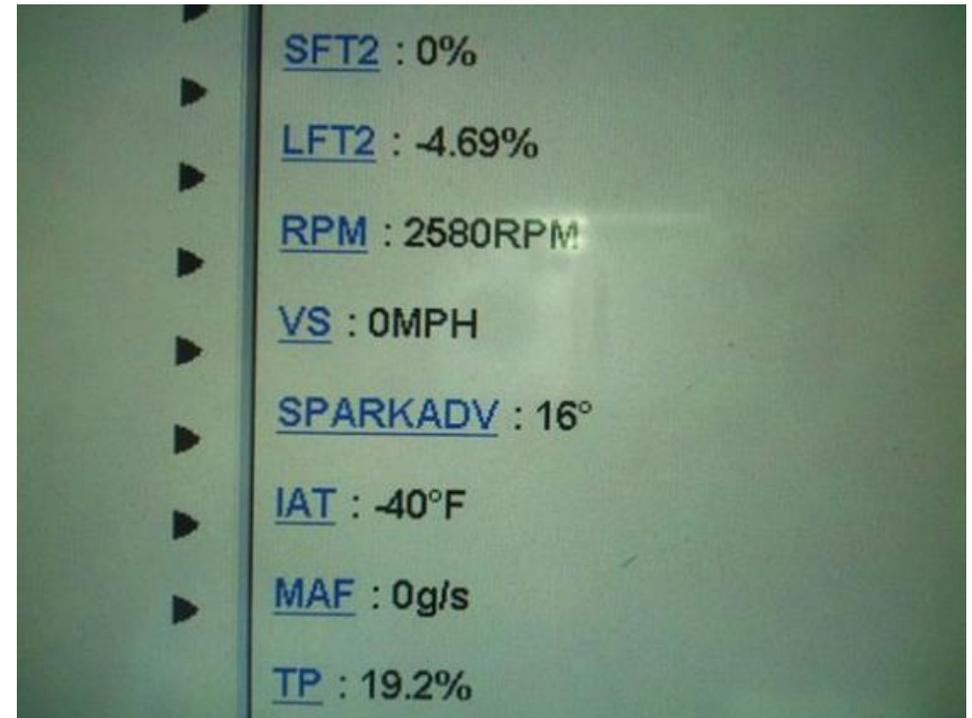
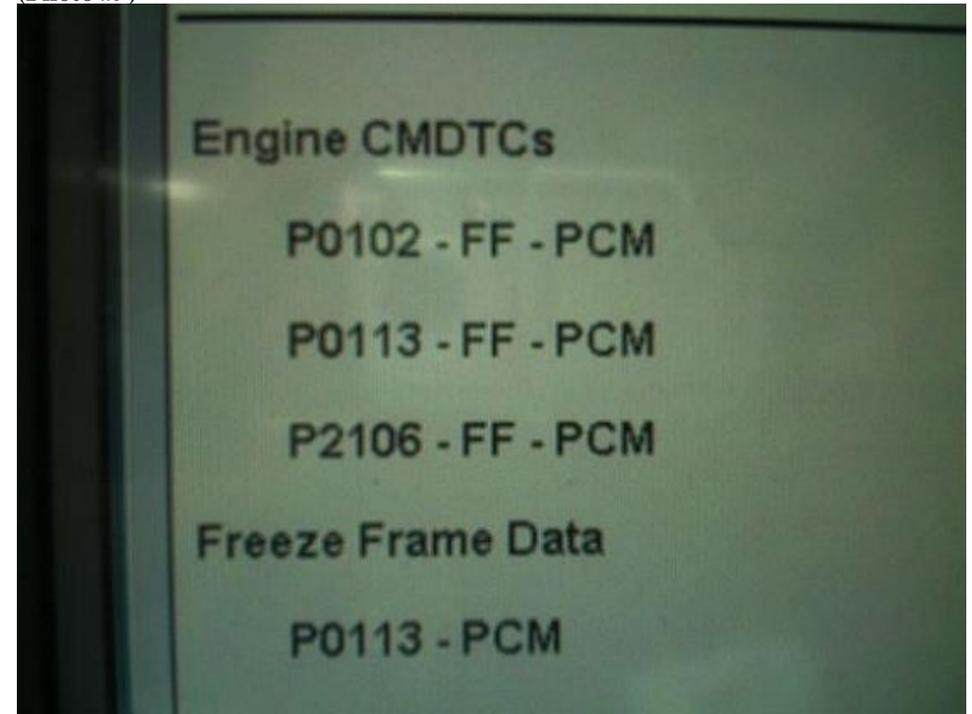
(Photo #8)

As you can see, a code 2106 doesn't automatically mean that the fault exists in a dedicated ETC component. In photo #10, you can see that this '05 Expedition has set a 2106. Check engine light illuminated and "Engine Failsafe Mode" message was displayed on the message center (photo #8). What set the 2106? Notice the MAF code and the IAT code. Looking at photo #9, we see that the mass air flow sensor had been found by the PCM to be out of range at the time the code was set. Since the ECT system is torque based and MAF sensor is required for the PCM to calculate torque, the disconnected MAF didn't just set MAF and IAT codes, but it also sent the PCM in to an ETC failsafe mode, code P2106.

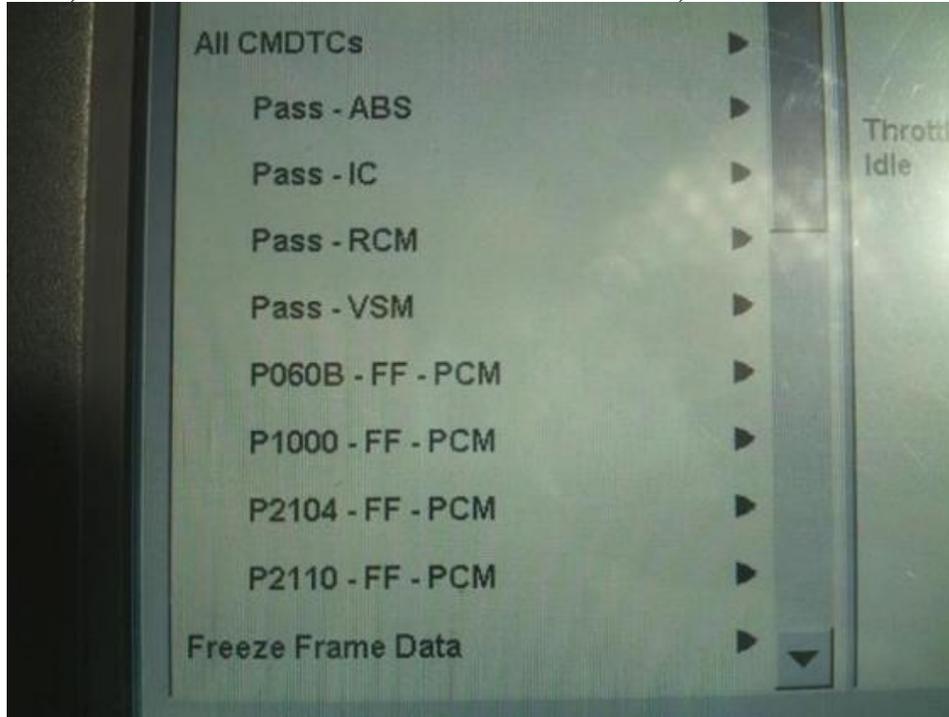
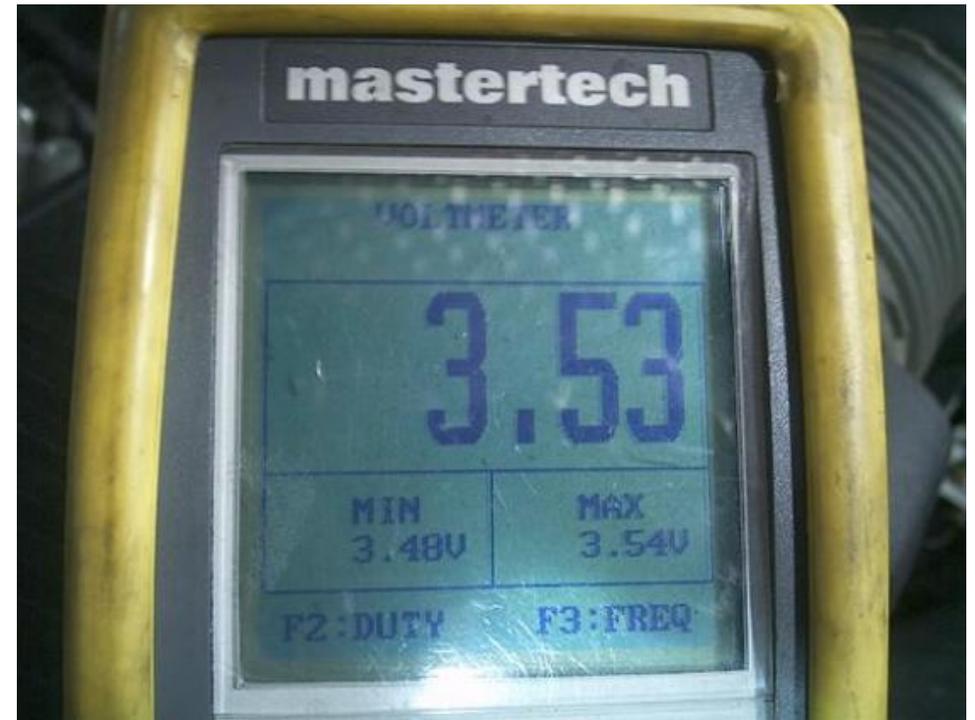
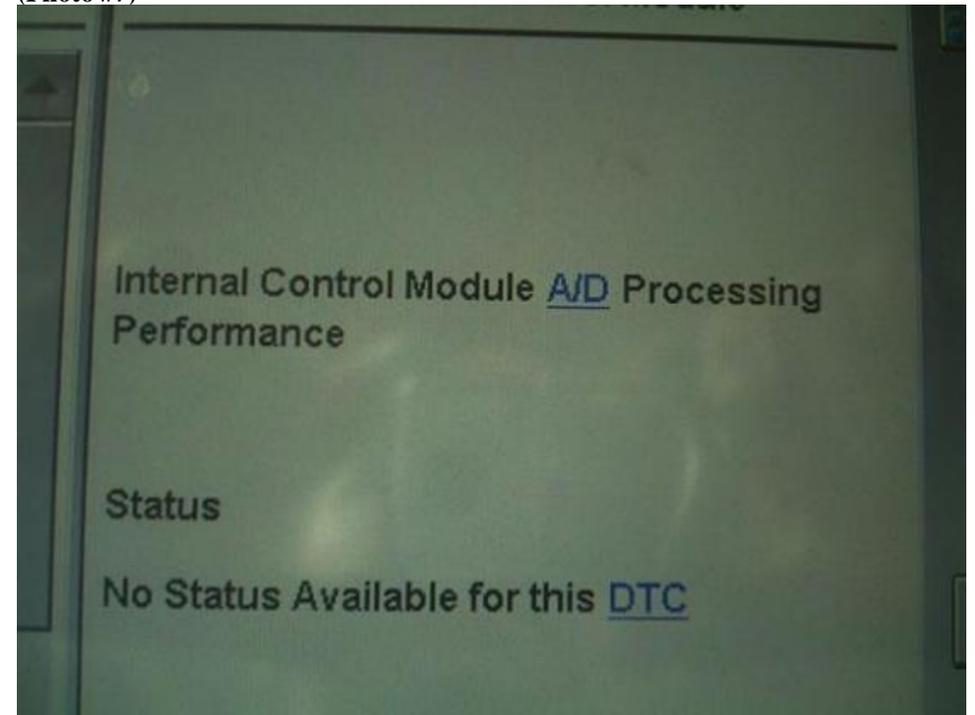
(Photo #5)

In another instance, an F150 came in with a forced idle and limited RPM condition. The wrench light was illuminated. The engine was not responsive at all to the throttle pedal. The throttle plate was defaulted to the 8 degree setting. When the vehicle was not in motion, the PCM would induce a misfire to bring the RPMs down to idle speed. Then, when in motion, the PCM would stop inducing the misfire to provide a high-idle condition which would provide a top speed of around 30mph. Codes P2110 and P2104 were both set (see ETC photo #5). According to the description and operation, and considering the most likely, the suspects are APPS, TPS, and internal PCM faults. When scanning the APPS and TPS, both PIDs were normal and resembled the examples shown earlier in figures 1 and 2. The wiring was then checked between the TAC and the PCM as a precaution by unplugging the lead to the TAC and measuring at the open ended harness pigtail. This quick test shows that at least the wires are not open (photo # 7). This voltage is normal to be found on both leads to TAC with key on, engine off. The cause of the truck's lack of throttle is found in that funny looking code back in photo #5. The code P060B is part of a newer line of trouble codes that will be more common in the coming years. P060B is for "Internal control module analog to digital processing performance" see photo #11. Simply put, the PCM recognized a fault within its analog to digital converter. That P060B is part of a new line of codes that will continue to grow as time goes on. Another of these is P060X for "internal processor failure". As you can see, the little letter at the end of the new codes does make a significant difference, because a P060 is a completely unrelated description of "HO2S Heater Resistance (Bank 2, Sensor 2)".
